Proposed Developments at Frankfort Castle and Frankfort Lodge,
Dundrum, Dublin 14

Conservation Report and Heritage Impact Assessment

March 2021

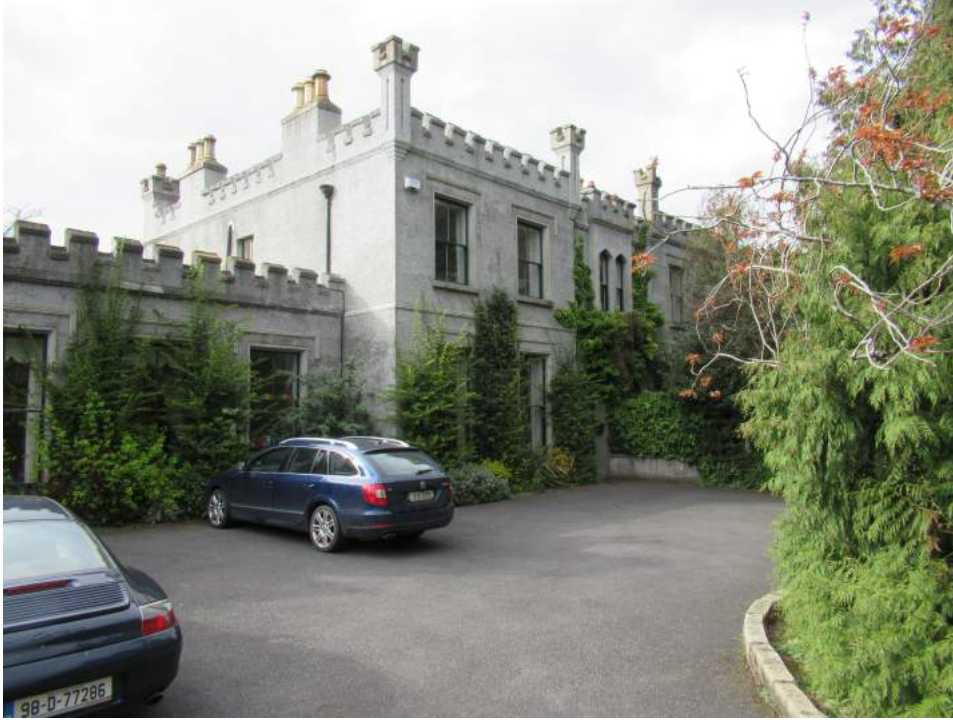
Plate No. 5. View of Frankfort Castle from the south-east. The single storey section at the left is believed to date from ca. 1860, along with most of the two store main structure.

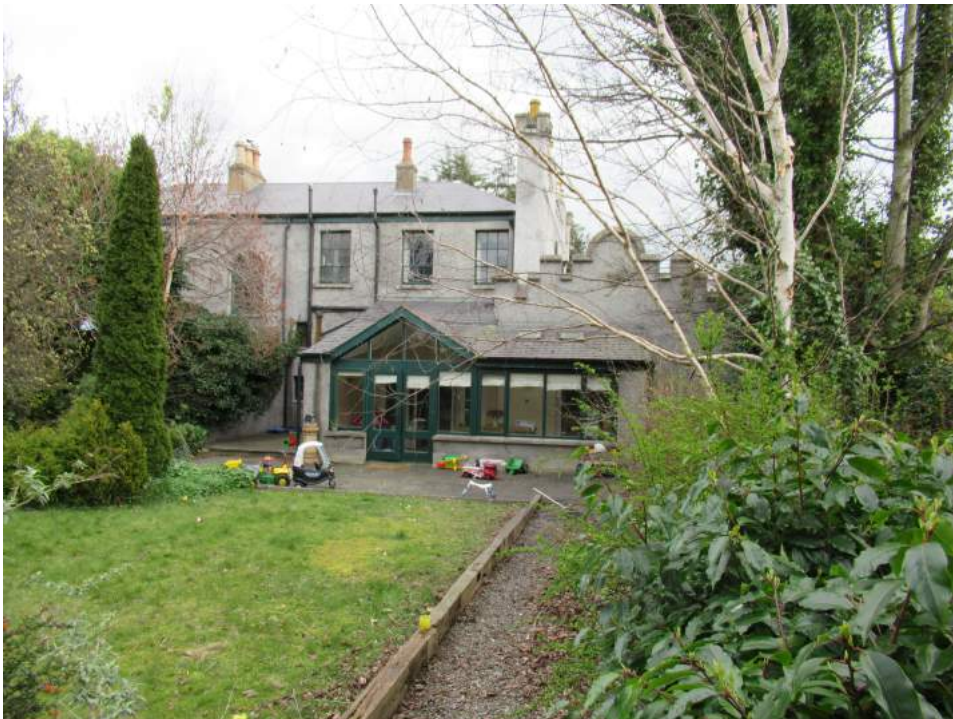
Plate No. 6. View of Frankfort Castle from the west, showing the southern end of the structure. The glazed kitchen extension dates mostly from the late 20th century, except for the ornamented gable, which is believed to possibly date from the ca. 1930 subdivision of the house.

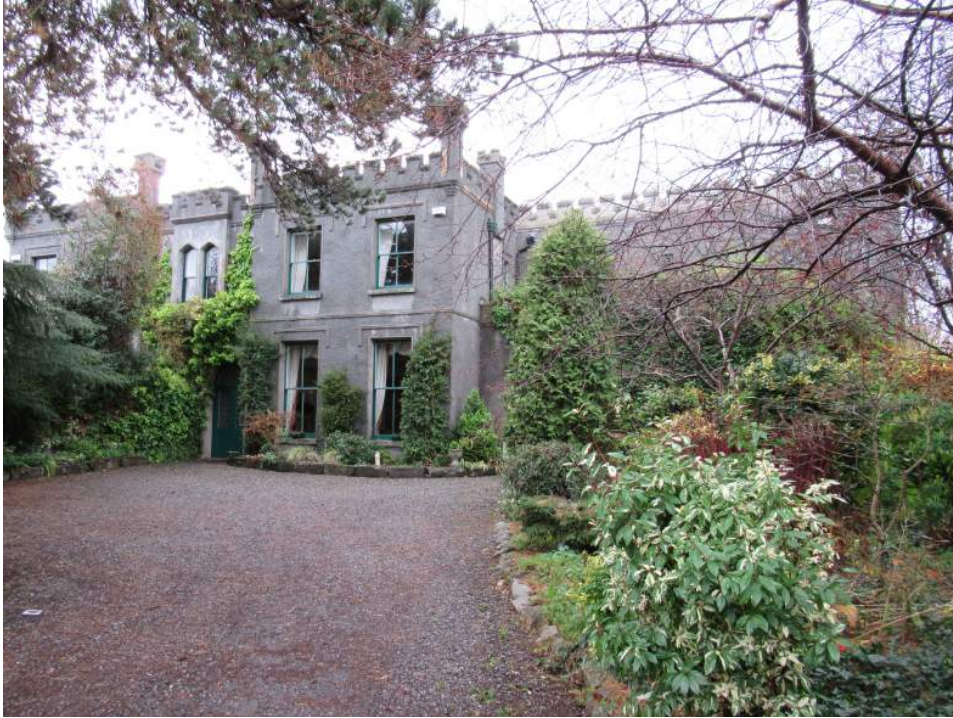
Plate No. 7. View of Frankfort Castle from the north-east, showing the northern end of the structure. The original symmetrical east front can be seen at left, having been subdivided around 1930. The recessed two storey extension at the right dates from the late 20th century.

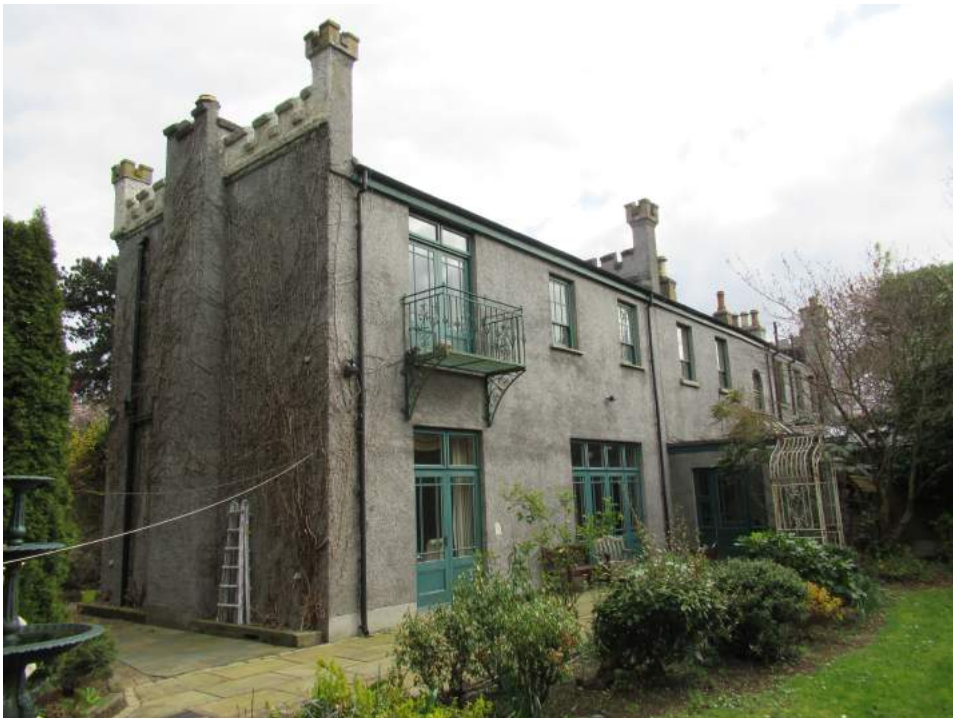
Plate No. 8. View of Frankfort Castle from the north-west, showing the late 20th century north extension.

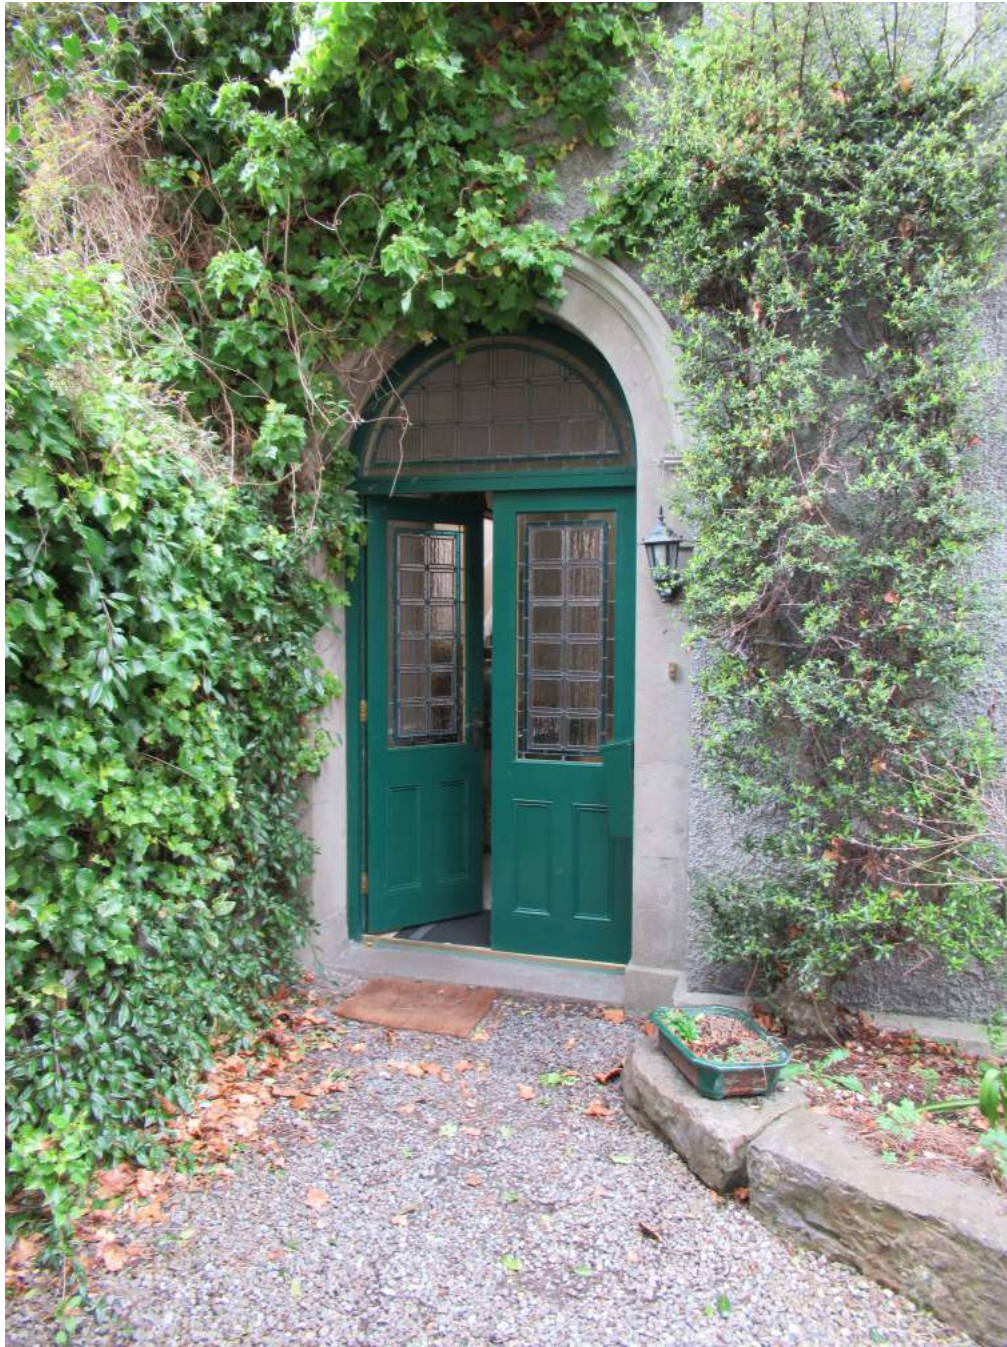
Plate No. 9. Detail view showing the east front door to the northern half of the original house. There is a similar door on the opposite side of the thick hedge at left, leading into the southern half of the original house. Historic Ordnance Maps show a small entry portico or porch attached to the front of the house in this location, probably with a single grand central entrance door.

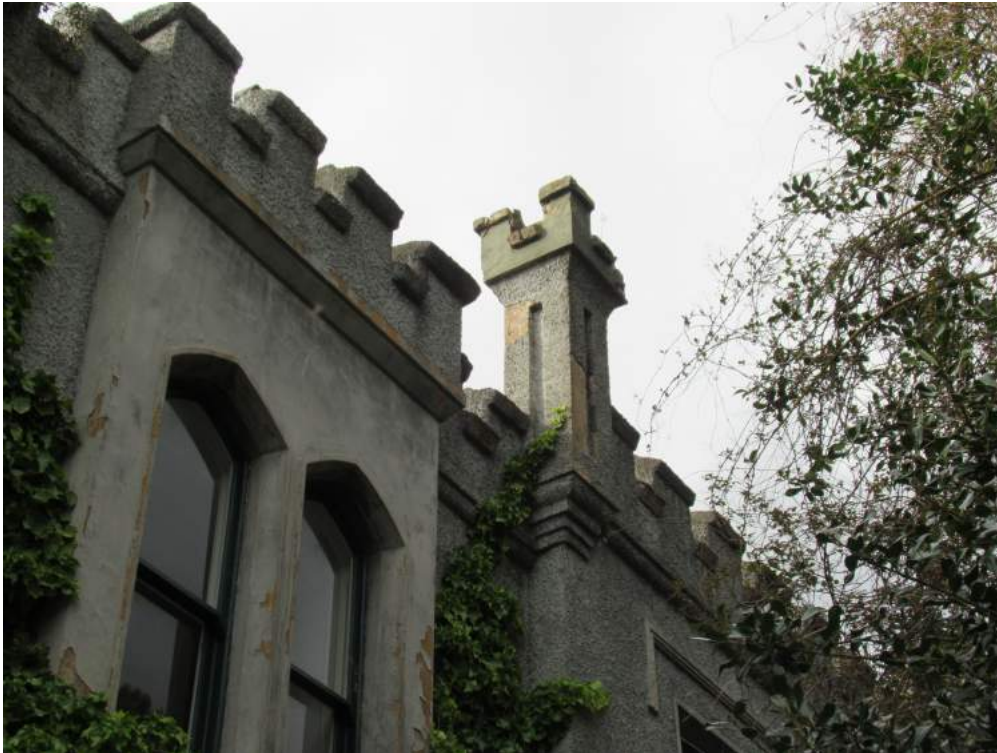
Plate No. 10. Detail view showing the mid-19th century mock Tudor details on the east elevation. All of the patent cement renders and moulded features were covered with Portland cement dashing during the 20th century. Some of the dash has fallen off revealing the 19th century patent cement render beneath.

The external render requires attention on all elevations. When originally built, the house was covered with a smooth render consisting of patent Roman cement and sand, and finished with a ruled final coat of lime putty and sand, and lime wash. During the late 20th or early 21st century, a layer of sand and cement dash was applied to the face of the old render. This material is not compatible with the breathable historic renders and will be removed. The lime renders will then be carefully repaired under the supervision of the project's conservation advisor. Similarly, the roof will be re-roofed using natural slates and lead or copper valley linings.

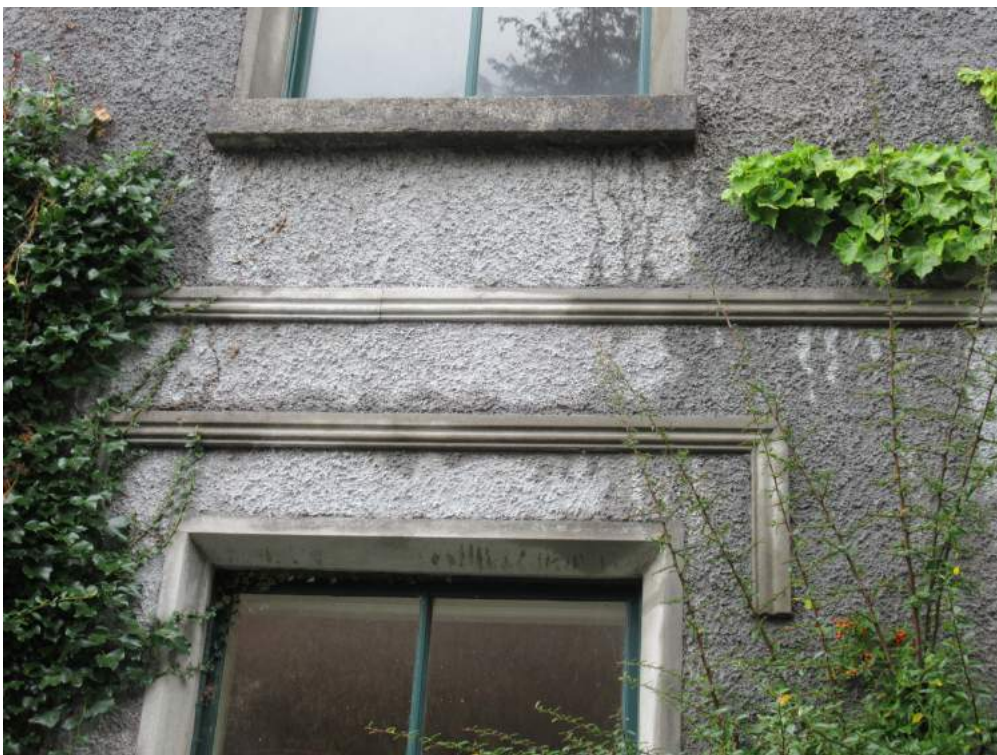
Plate No. 11. Detail view showing some of the windows on the east elevation of the original house. Note the cementitious dashed render, and the precast sand and cement ornament.

Several individual repairs are required to the property. The timber sash windows have survived in most locations, but require skilled repairs. Where possible, the single glazing will be replaced by slim double glazing, to improve thermal efficiency. Where this is not feasible, secondary internal glazing panels will be used to improve the heat retention of the windows.

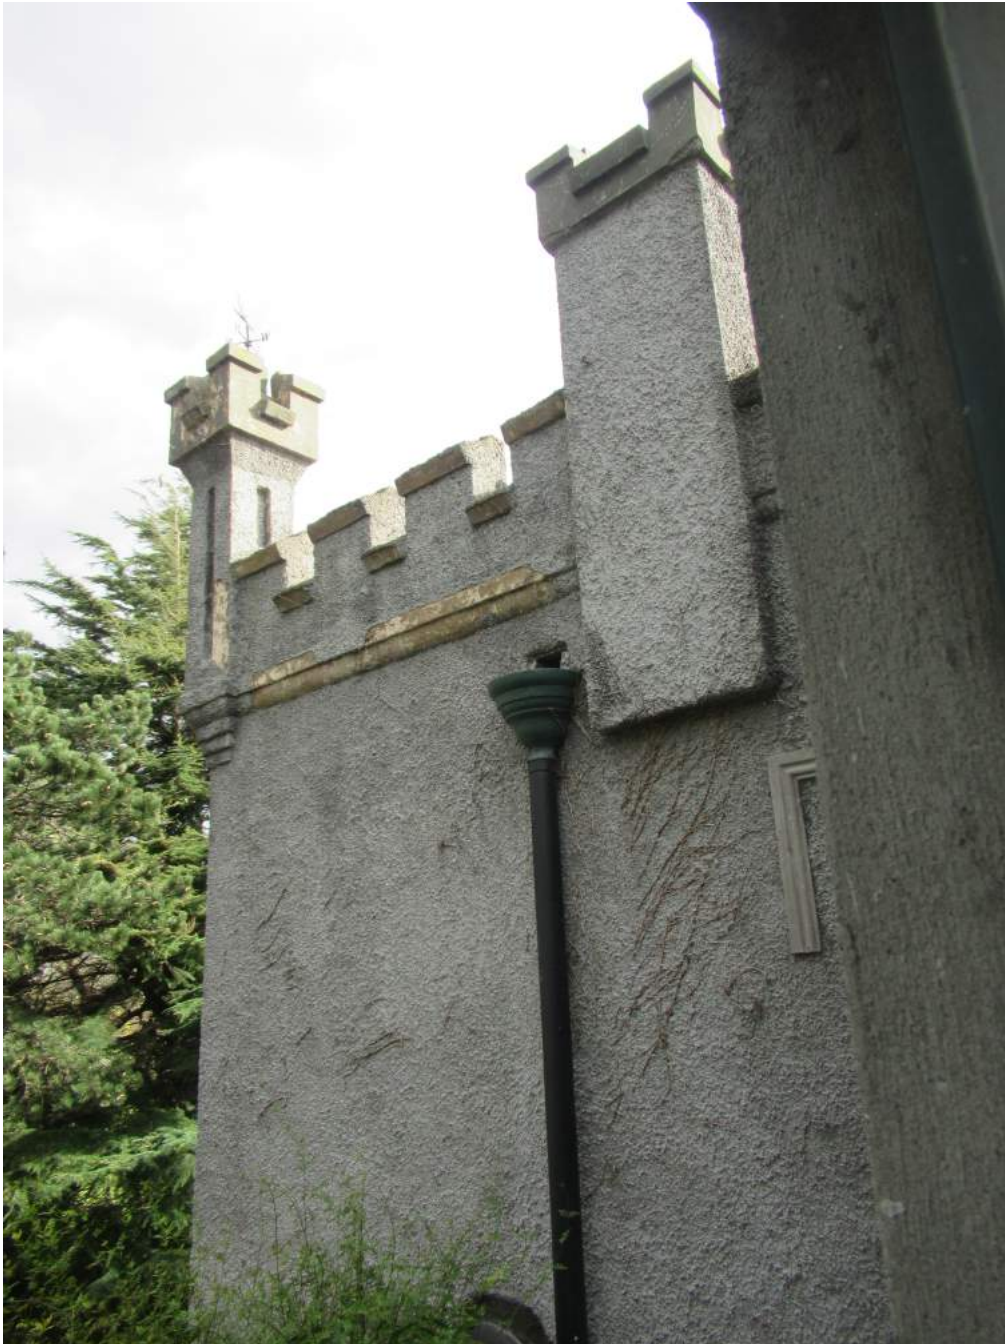
Plate No. 12. Detail view showing the north elevation of the original house, with the 20th century extension at the right. Note the original patent cement moulded string course below the battlements, exposed by the failed cementitious dashed render. It appears that the earlier brown patent cement render had been finished with a yellowish finish coat.

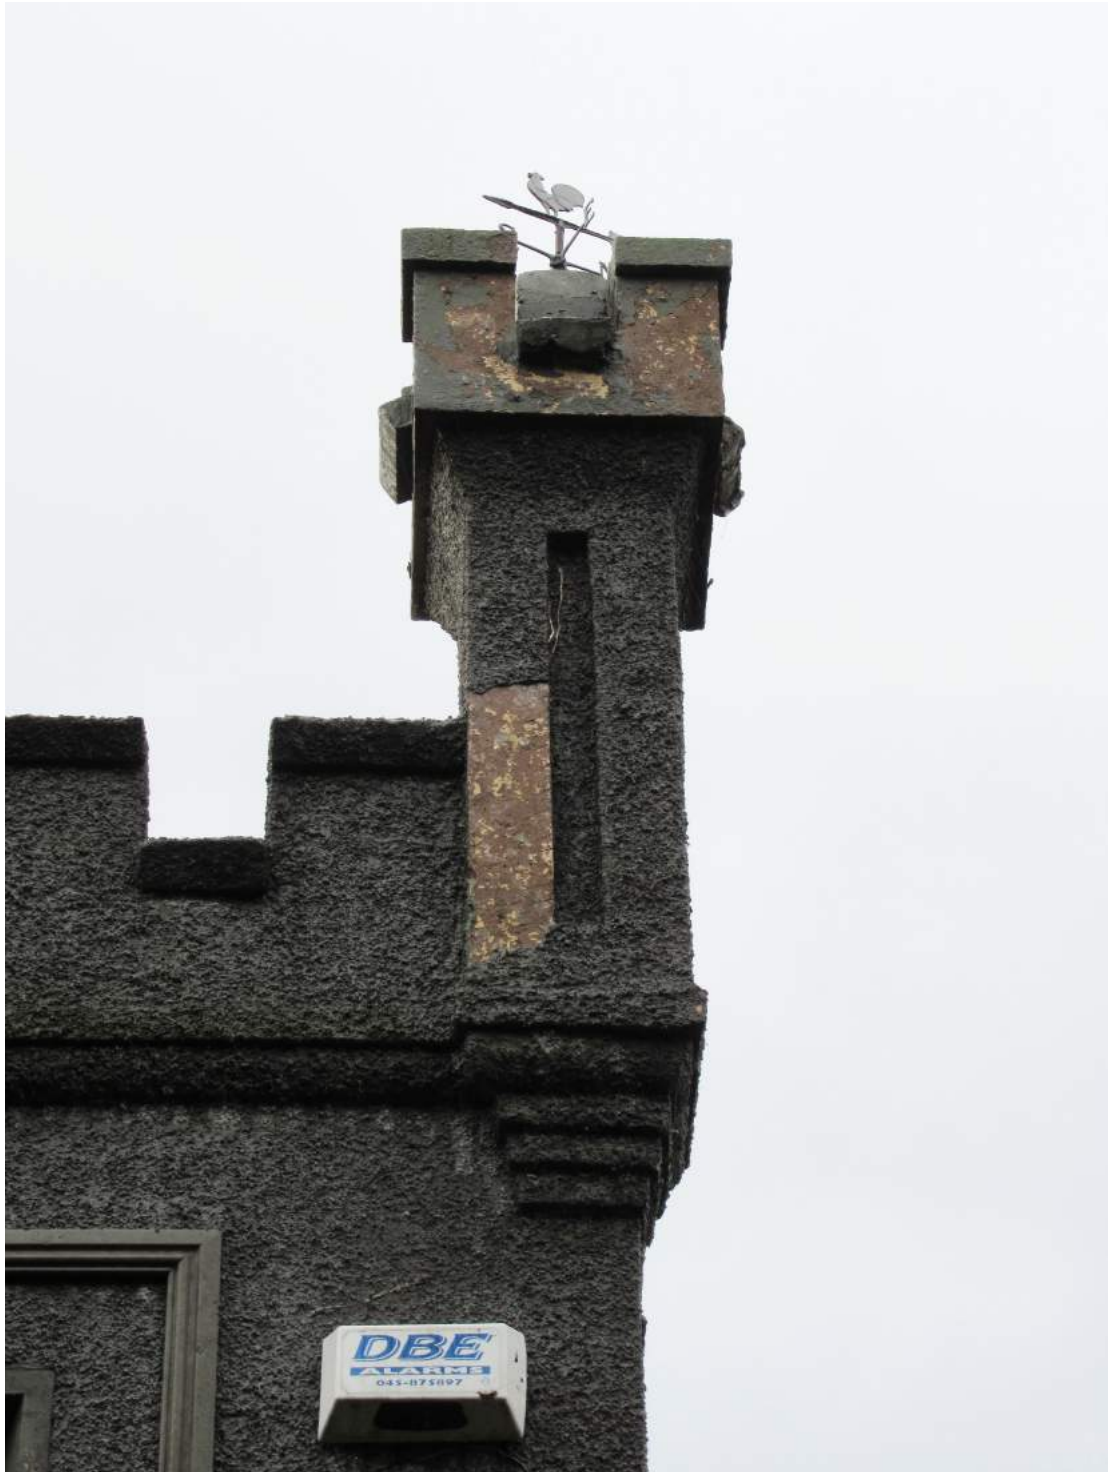
Plate No. 13. Detail view showing one of the rendered masonry corner battlements, on the primary east elevation to Frankfort Castle. This photo clearly shows the original brown coloured patent cement render under the late 20th century sand and cement dashing. Note the late 20th century cast sand and cement moulding over the window at the left.

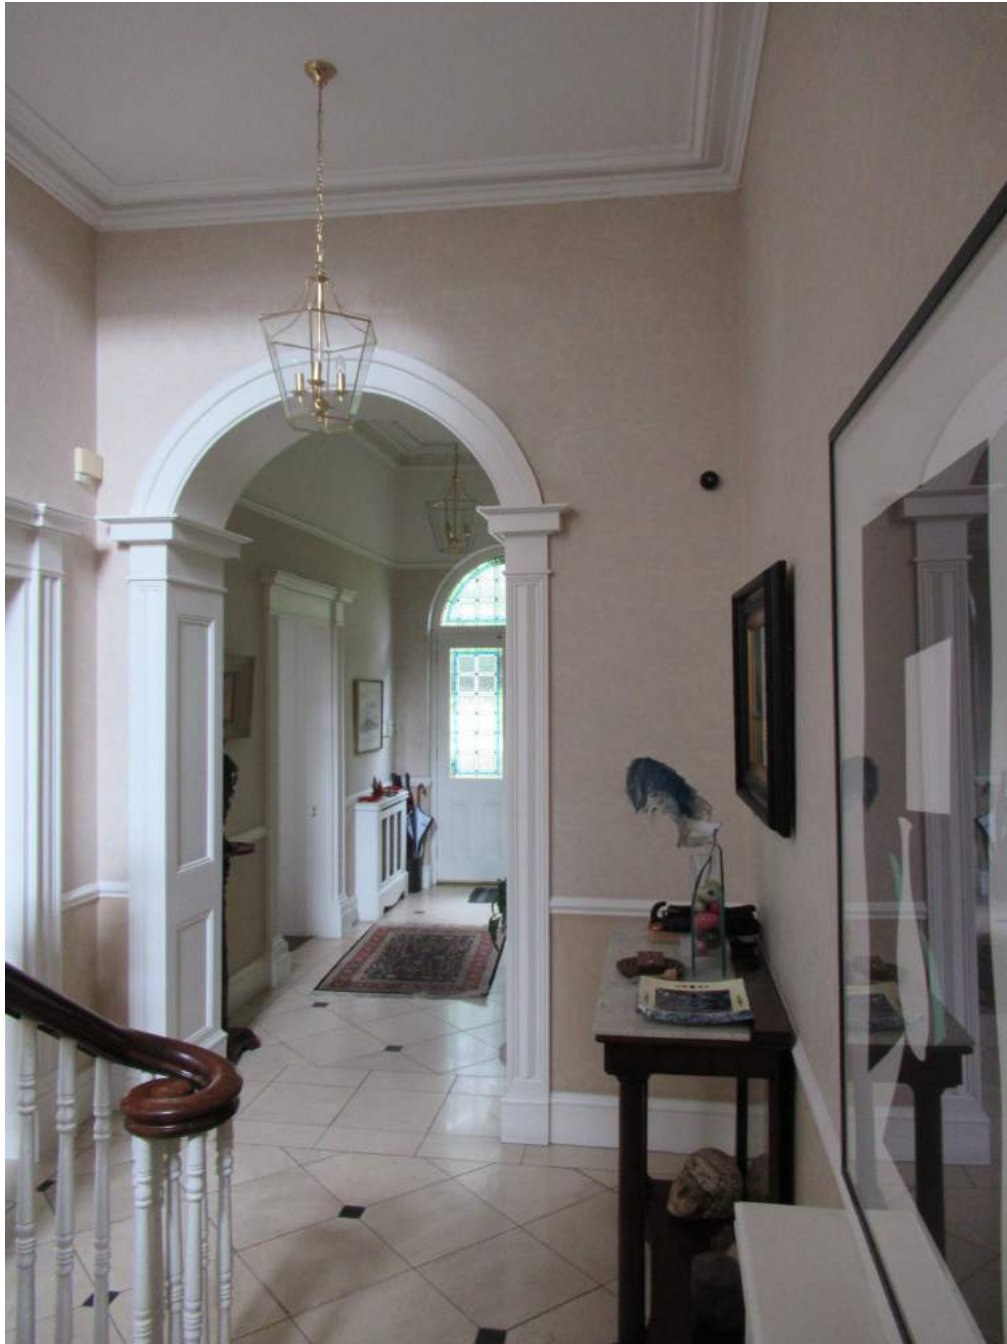
Plate No. 14. Internal view in the ground floor stairwell in the northern half of the original structure. It is believed that most of the features seen in this view date from the ca. 1860 reconstruction of the house. The glazed entrance door and transom date from the ca. 1930 division of the house into two separate properties. The floor tiles date from ca. 2000 when the northern half of the house was extended and refurbished.

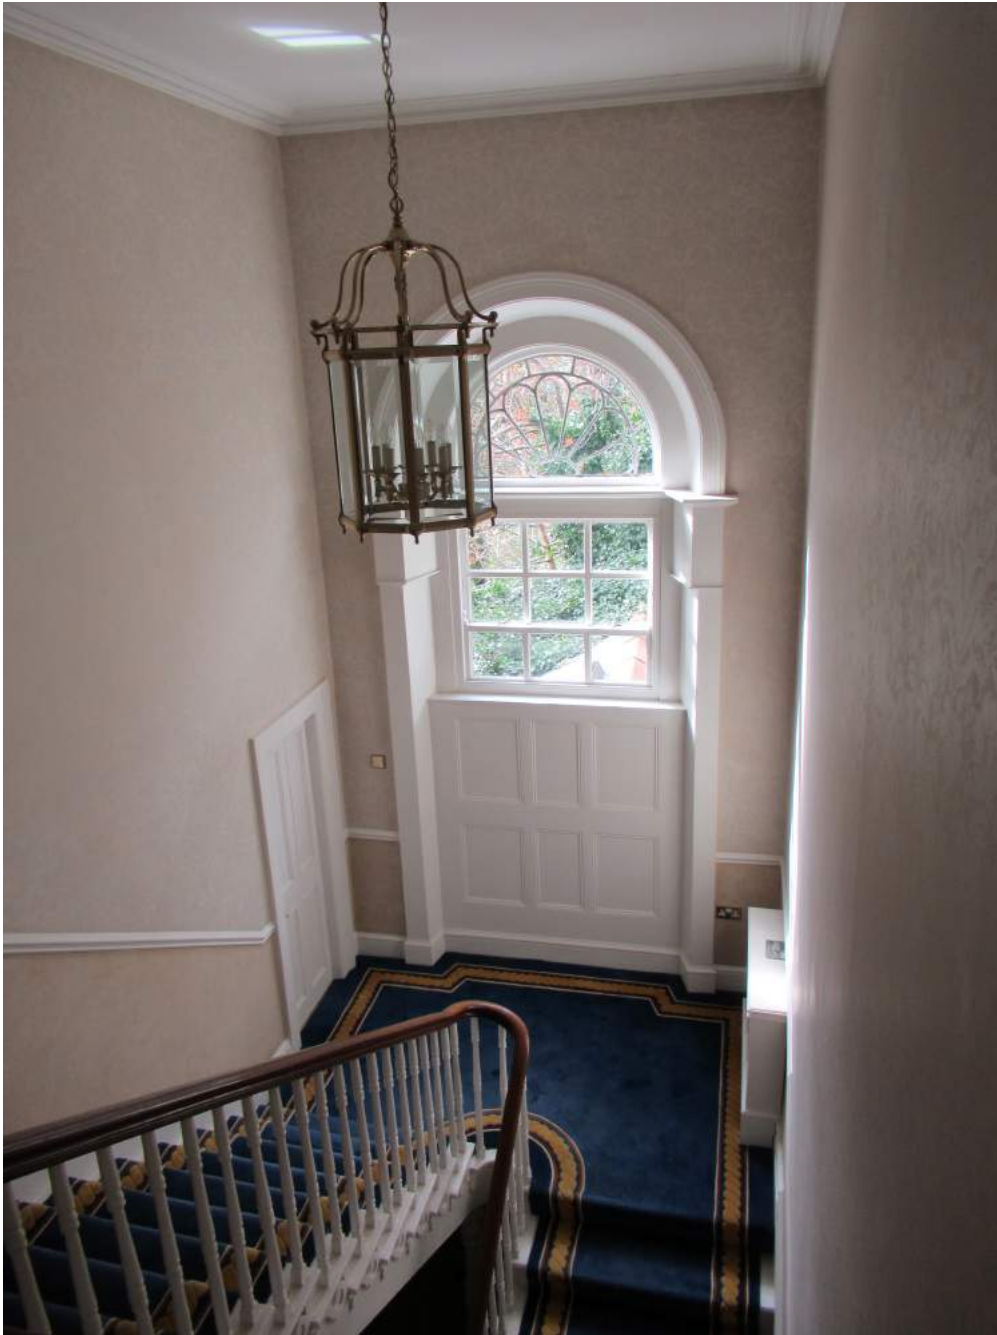
Plate No. 15. Detail view showing the stair landing in the northern half of the former Frankfort Castle. It is likely that the arched window originally extended nearly to the landing floor, but was partially blocked by the double pitch roof over an early 20th century extension to the rear.

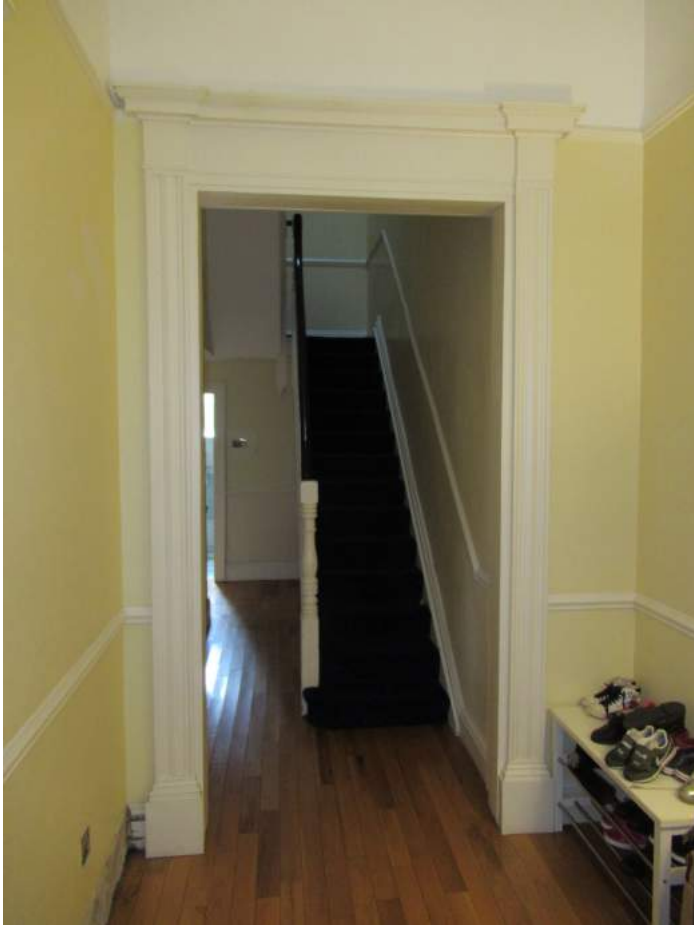
Plate No. 16. Detail view showing the stairwell in the southern half of the structure. This narrow stair likely dates to ca. 1930 when the original house was subdivided.

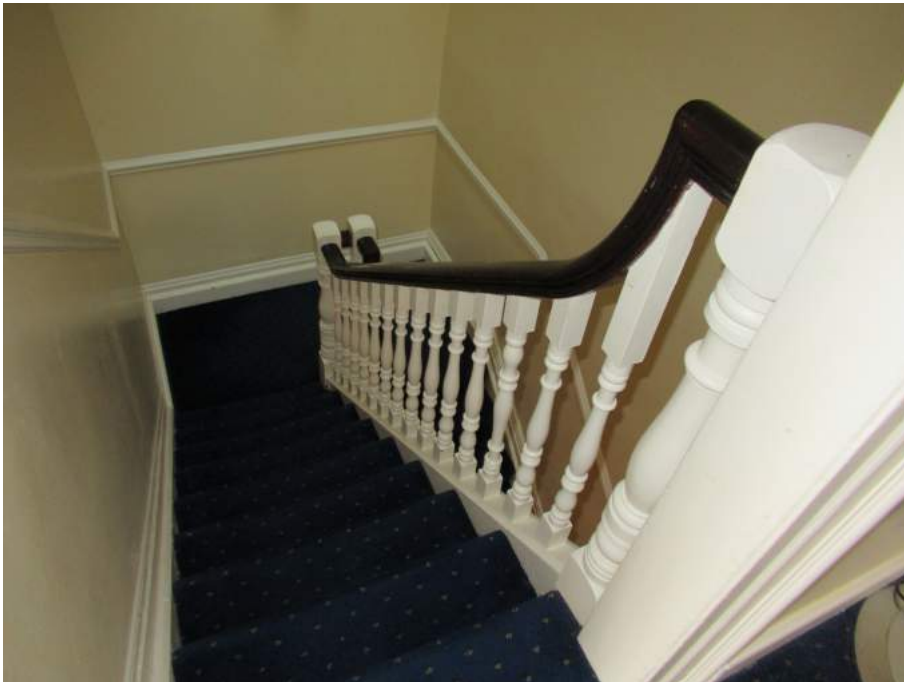
Plate No. 17. Detail view showing the ca. 1930 staircase in the southern half of the property.

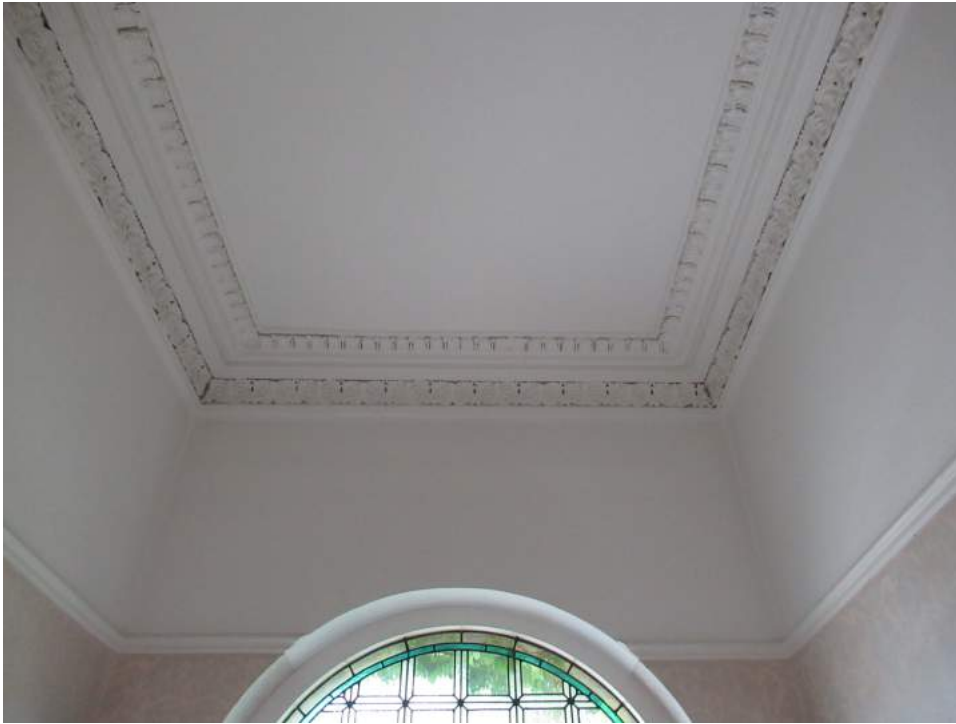
Plate No. 18. Detail view showing the ceiling in the entry hall in the northern half of the property. Close examination reveals that the wall at right, and the plaster coving above that wall, were later insertions into the original larger entry.

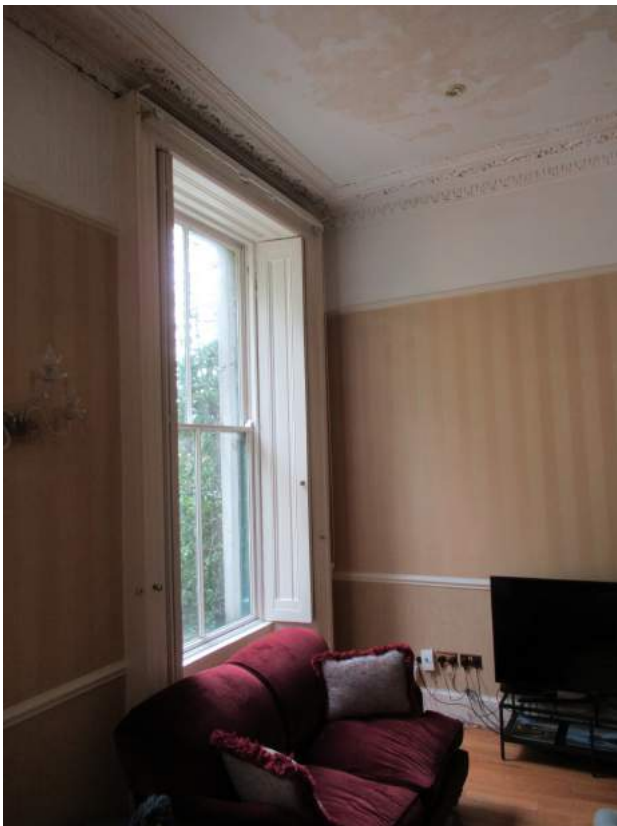
Plate No. 19. Detail view in the southern sitting room, showing the internal joinery and plasterwork dating from ca. 1860. Note the damage to the ceiling from leaking bathroom plumbing.

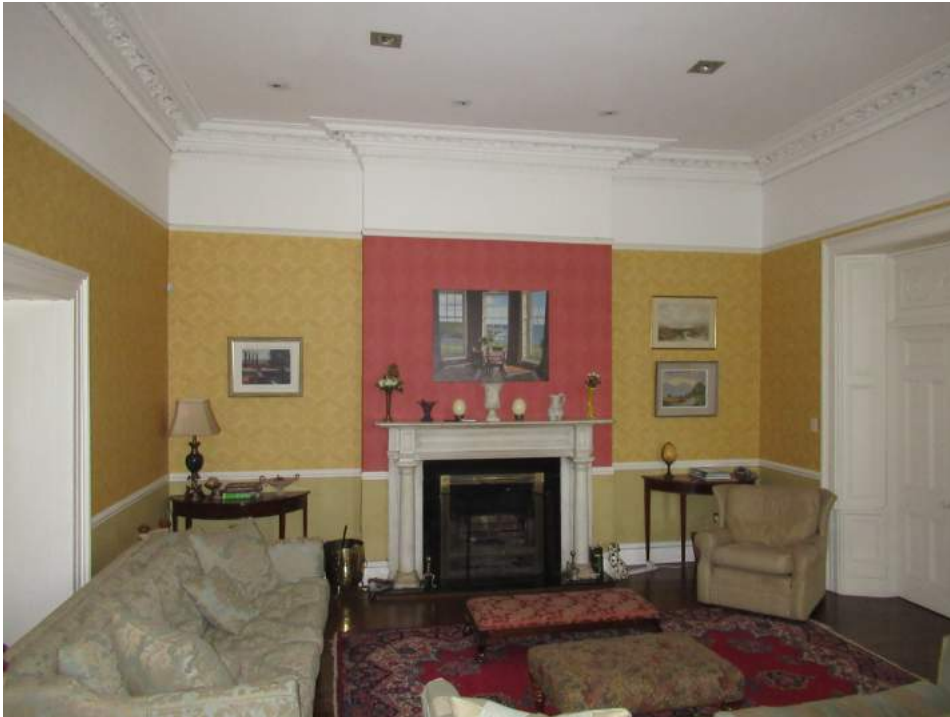
Plate No. 20. Detail intern view showing the sitting room in the northern half of the original house. This room retains mid-19th century joinery, plaster coving and marble chimneypiece.

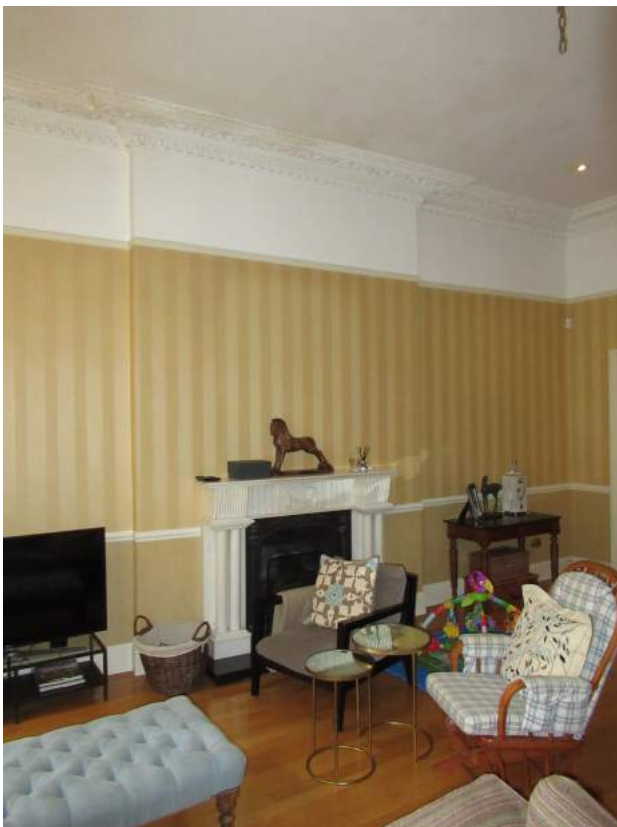
Plate No. 21. Detail internal view showing the fireplace in the sitting room in the southern half of the original house. Like its northern counterpart, this room has retained its mid-19th century joinery, plaster coving and white marble chimneypiece.

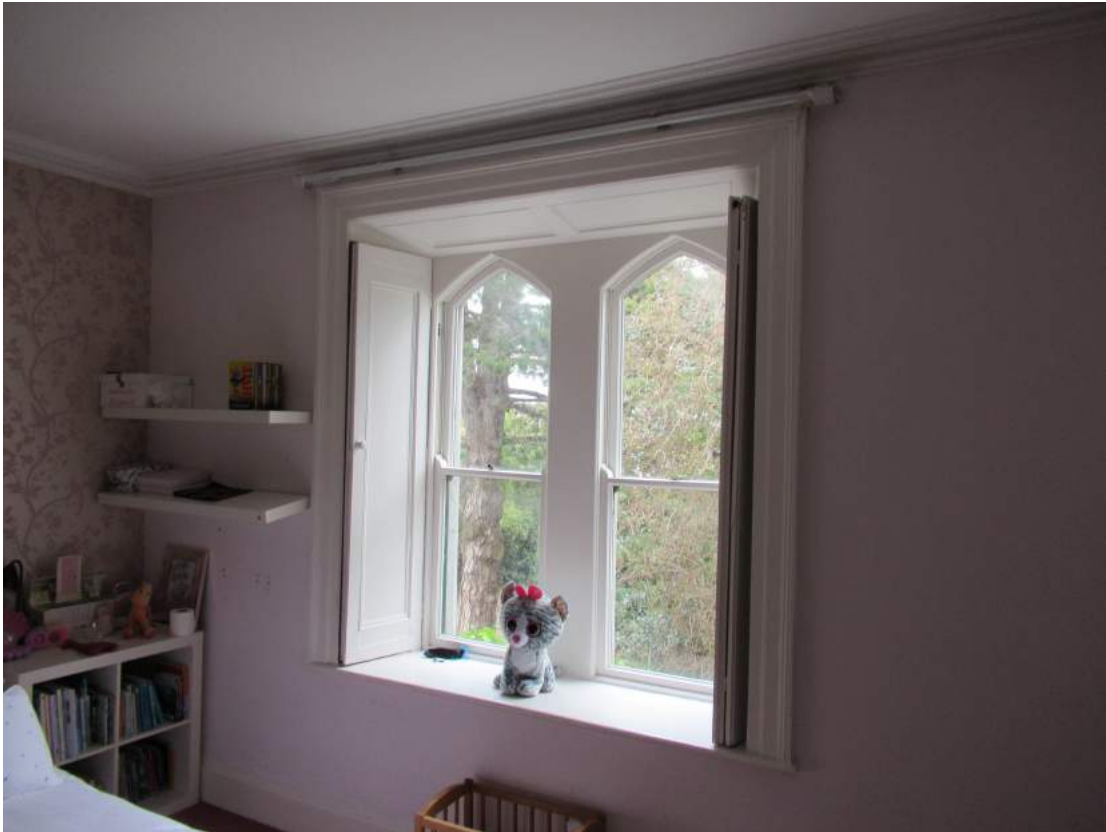
Plate No. 22. Detail internal view showing the internal window joinery in the first floor roof over the original entrance.

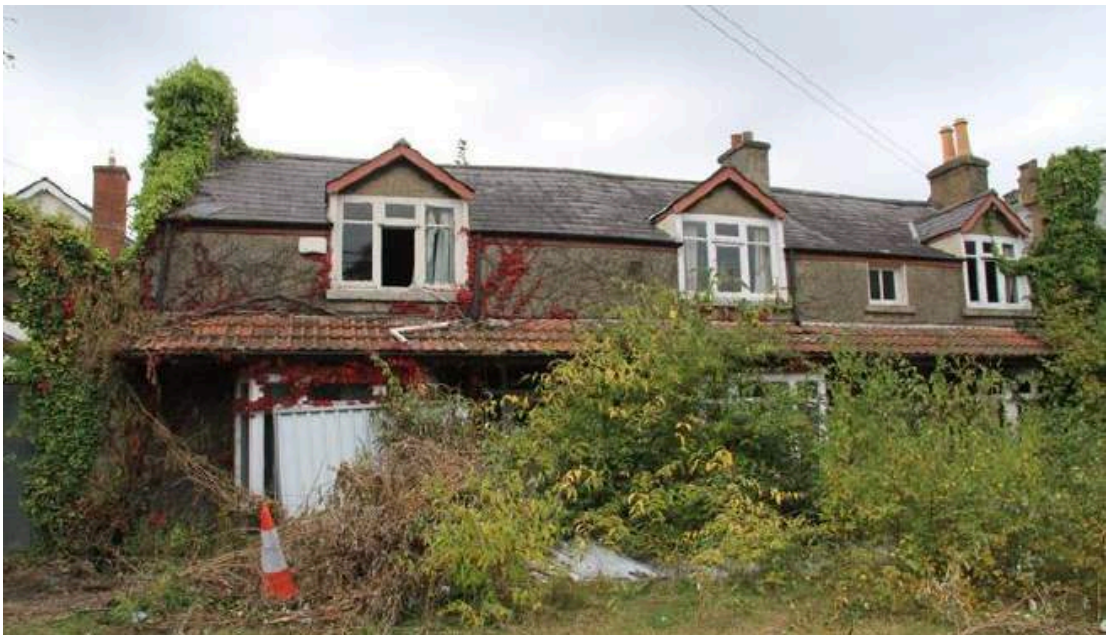
Plate No. 23. General View showing Frankfort Lodge, attached to the south end of Frankfort Castle.

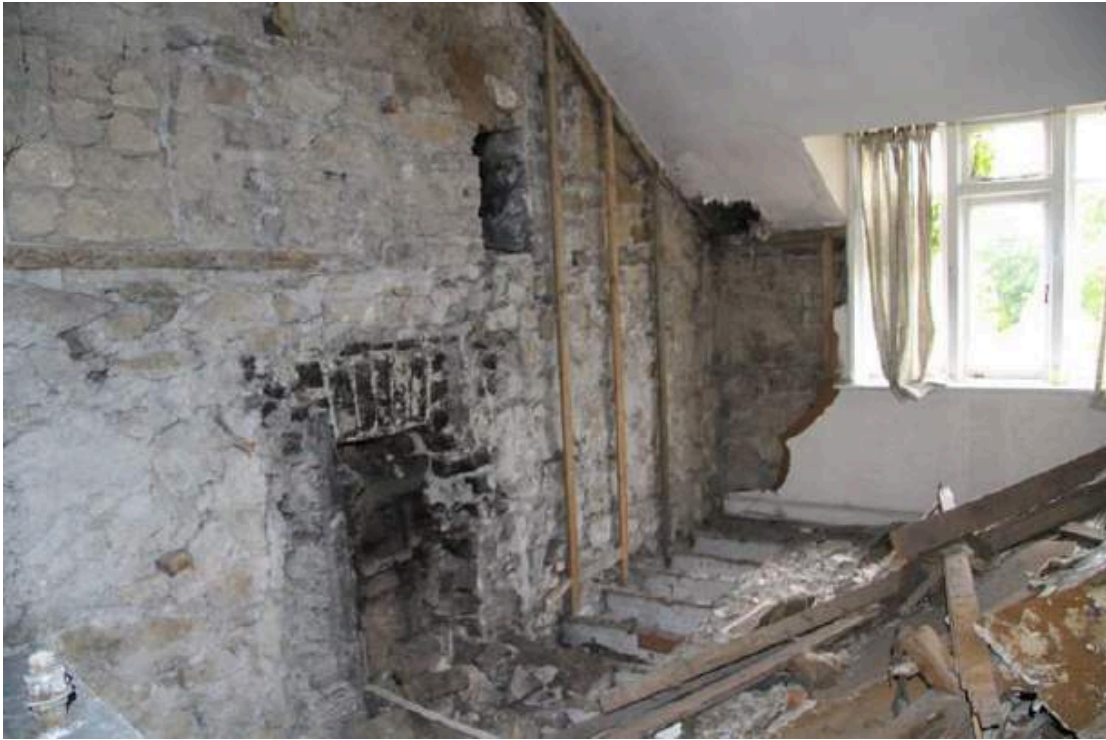
Plate No. 24. General View showing the current internal conditions at Frankfort Lodge. The entire structure is derelict and ruinous. The lodge was the result of extensive reconstruction of one of the former stable building, dating from ca. 1930.

It is proposed to demolish Frankfort Lodge, to accommodate the vehicular entrance to the site. Frankfort Lodge contains some stone walls that appear to date from the mid-19th century, when it most likely formed part of the stables for the suburban Frankfort Castle house. When the property was subdivided around 1930, Frankfort Lodge was created from remains of the stables, and formed a third separate domestic property from the original property. This structure has been vacant for many years, and has become thoroughly derelict and ruinous.

- The ruinous Frankfort Lodge will be demolished to allow for the overall development to proceed.
